**Antelope Guzzler Report**  
**Hatch Guzzlers Maintenance Report 2012**

**Summary of Maintenance and Repair Needs**

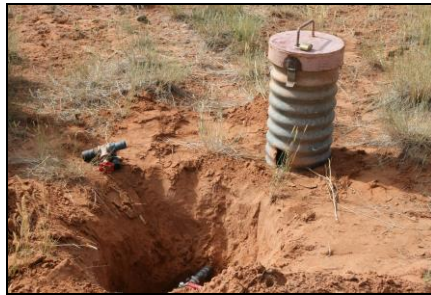
**No Soup Rock-UDWR**

**2012** – System was turned on in the spring and turned back off in the fall when the cows returned to the range. Sediment box was pumped out, cleaned and inspected. Storage tank has water and system is in good shape. Aluminum drinker has been damaged by cows and will soon fail, needs replaced.

***No Soup Rock: On-line Needs aluminum drinker replaced***

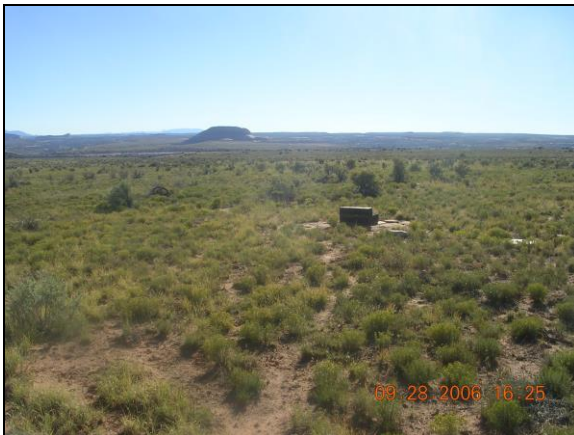
*Drinker*

*2011 – New drinker installed, system on-line 2009, 2010-System off-line, drinker was removed and installed at the Sage-grouse guzzler site. System offline-New system installed nearby in fall 2008*

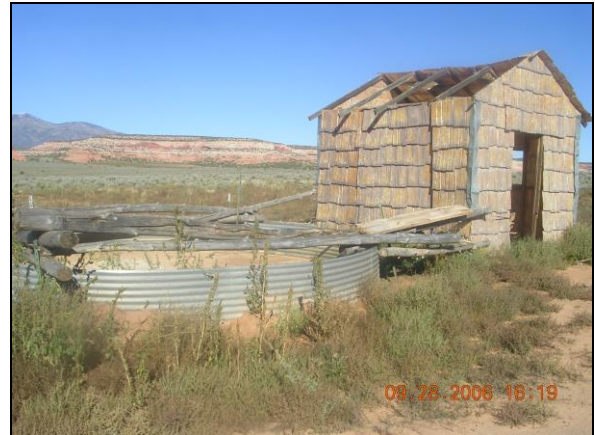
*Old pump house, cow tank & nearby storage tank*

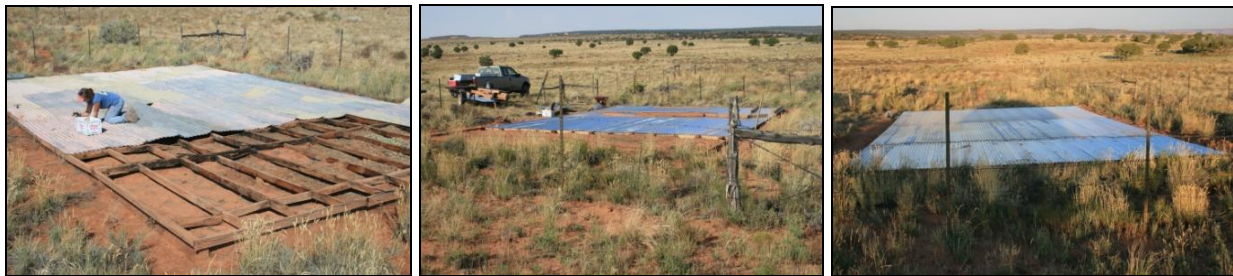
*Removal and Construction of new deck-2010*

**2010-** Drinker, valves & catchment replaced. New plumbing and valves were installed and system is back on line. New drinker and new valve box have been installed. New 42' X 24' catchment surface and base installed and gutter repaired. Storage tank has water.

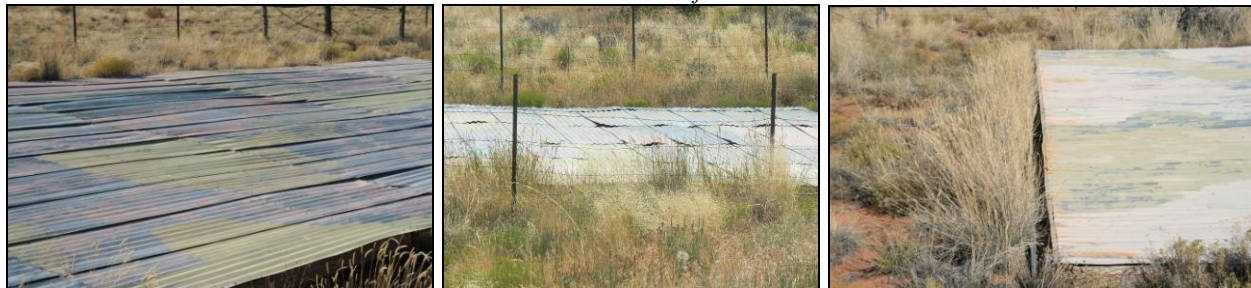
*Old Deck-2009*

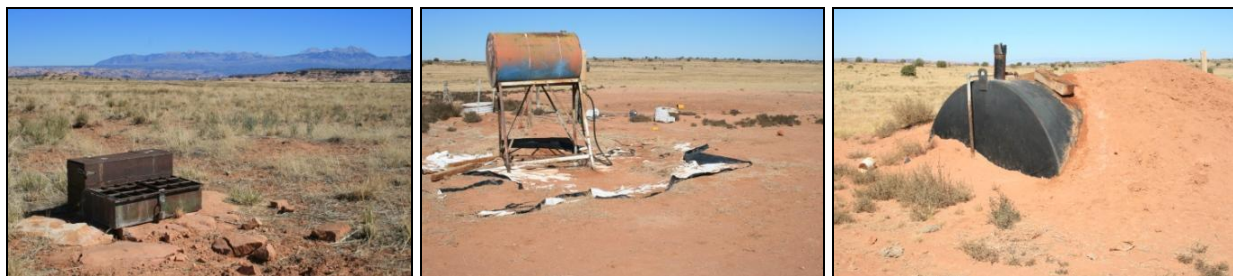
### Trough Flats

**2012** – System was turned on in the spring and turned back off in the fall when the cows returned to the range. Storage tank has water and system is in good shape. Still have permittee problems

**2010, 2011-** Inspected in the spring, in working order, water turned on. Storage tank has water. Turned off in the fall before cattle came on. **2009-** Permittees have a habit of draining it, though there was an agreement to leave all

*stock water in the tank for antelope use during the summer. We need to disable or lock the drain outlet. This appears to have also happened in 2008.*

***Trough Flats: Remove or lock drain***

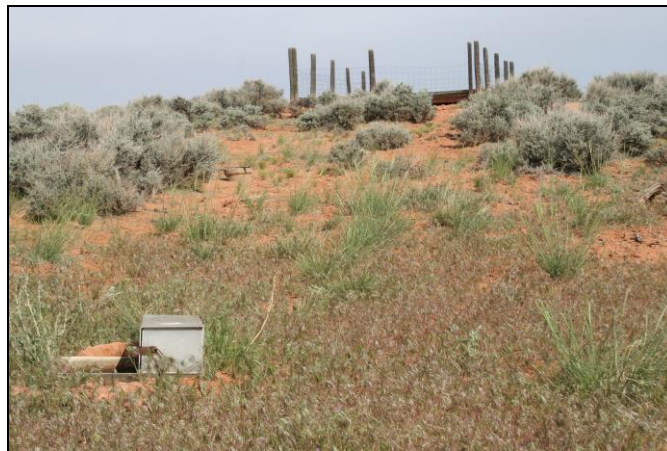
**Trout Water UDWR**  
**UTM NAD 27 Zone 12 623478/4243971**  
**No BLM Rights-of Way**

***2011** – System overhauled - Storage tank full. Catchment deck repaired, plumbing repaired. **2010-** Storage tank has water. DWR turned off in the fall before cattle came on.*

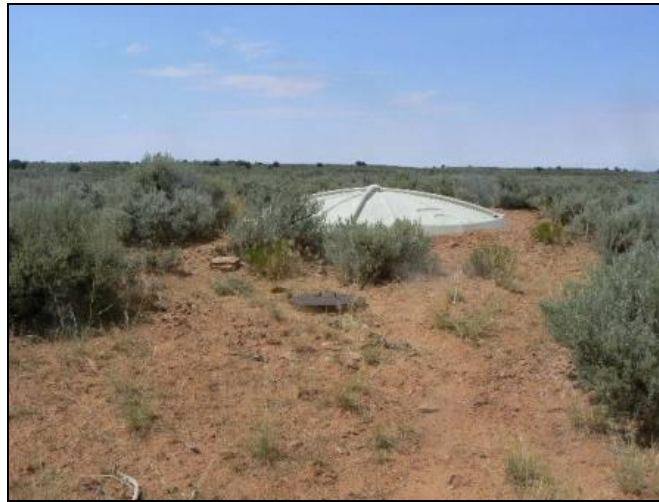
*Removed Saucer System*

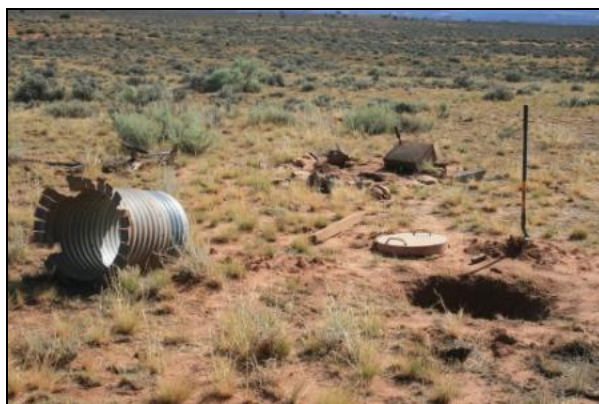
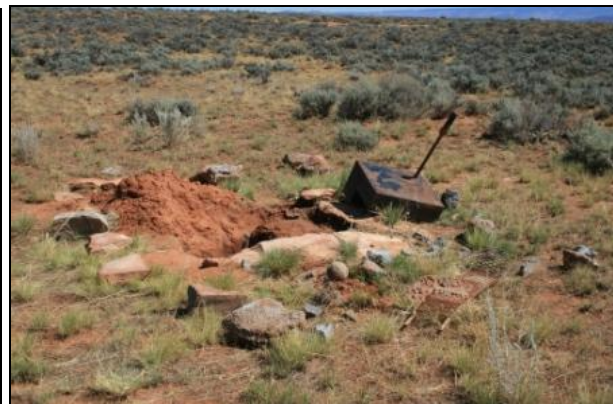
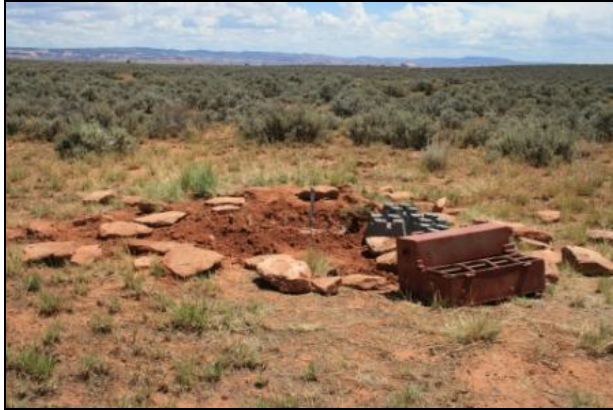
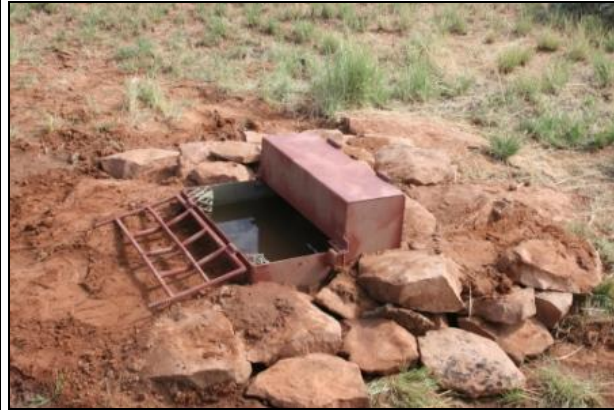
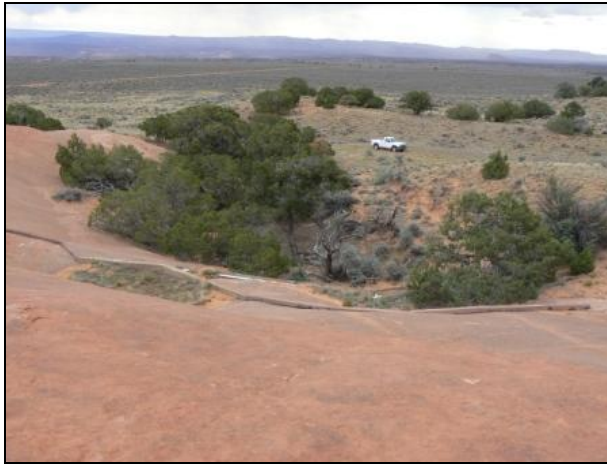
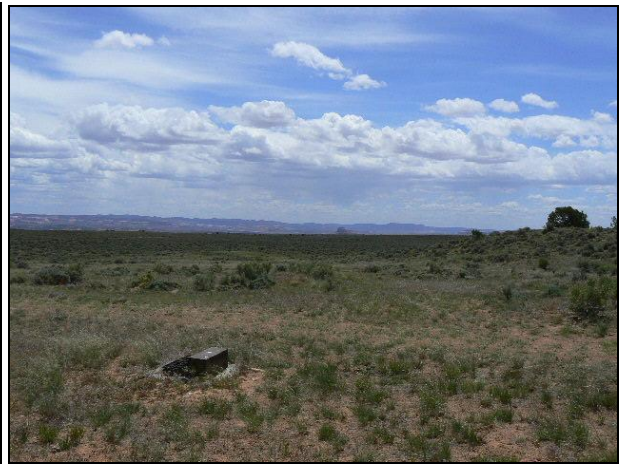
### **Eight-mile Rock**

**2012** –Both old drinkers were removed because they were leaking. One line was decommissioned and the other had a new drinker installed. System was then turned on and turned back off in the fall when the cows returned to the range. Storage tank has water and system is in good shape.

**2010, 2011-** System work and tank has water one of the two drinker on-line but are poor condition & leaking

***Eight-mile Rock: stabilize collection system***

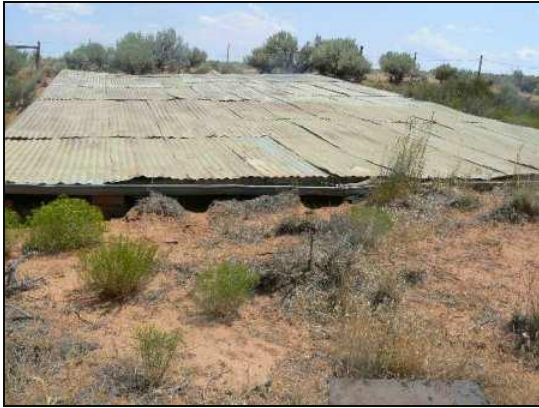
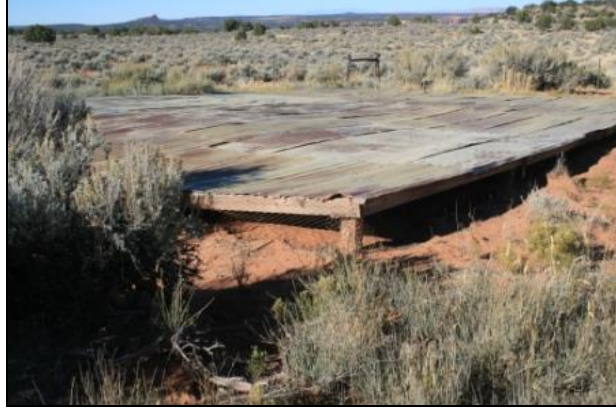
*Old, leaky system*

*2010-Refurbished drinker installed & system is back on-line. Still needs catchment re-furbished. 2009-Offline-drinker has bullet holes in it and someone turned it on and drained the tank. Catchment surface and frame in very poor condition.*

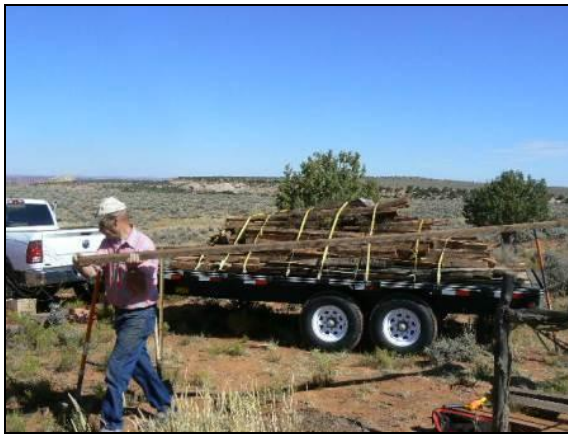
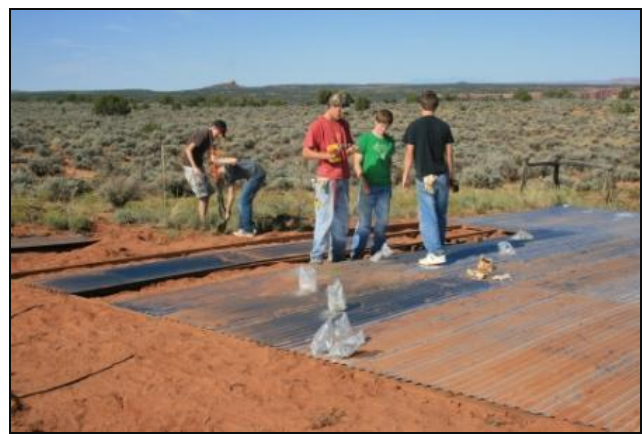
*A local Eagle Scout group removed all the old sheet metal, rotten wood, buried posts and pack rat nests, broke the old, leaky drinker from its cement housing, dug up the valve box, tore down the old fence and removed the overgrown sage brush and rabbit brush from inside the fence. They then re-designed and installed a new catchment surface and installed a new drinker, lockable valve box and new fence and cleaned out the sediment box. Kevin provided needed oversight.*

*Refurbishment*

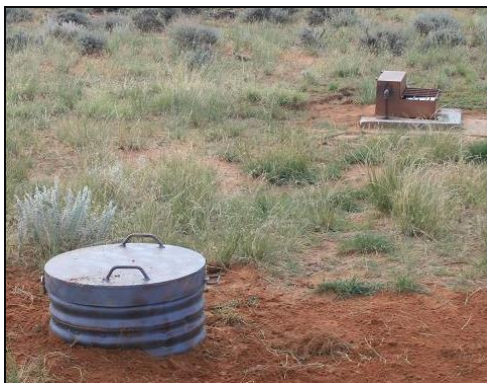
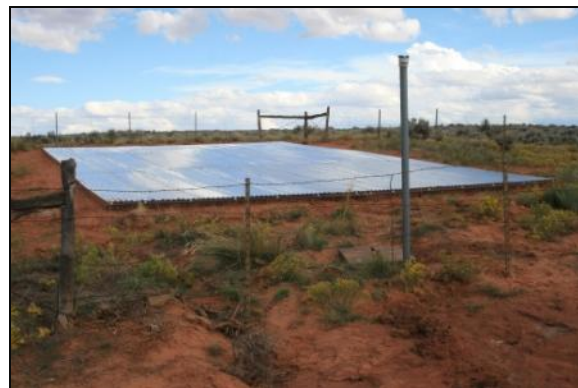
*New System*

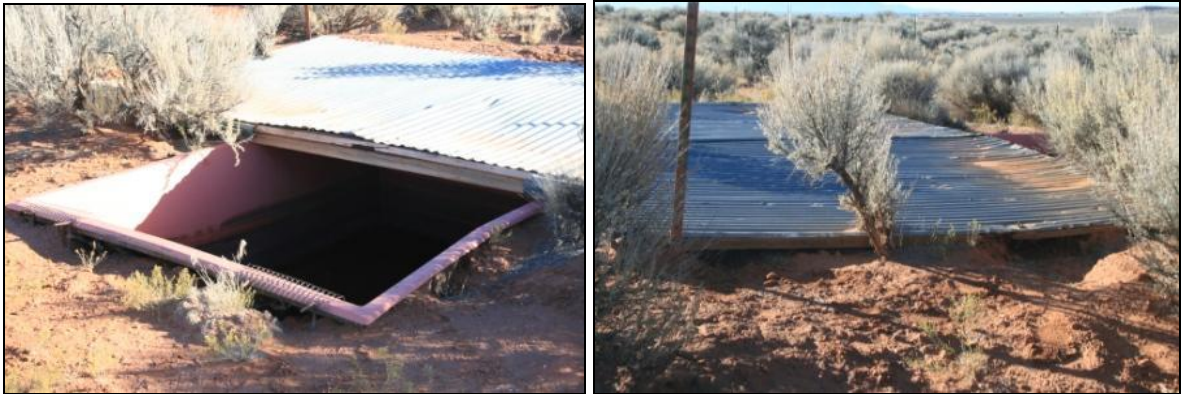
**Over the Hill-UDWR**  
**UTM NAD 27 Zone 12 626429/4240422**  
**No BLM Rights-of Way**

**2012** –Planned to decommission and removes when funding becomes available, as the Over the Hill Guzzler II is less than a mile away and in good working order. This location is in tall sagebrush making predation on fawns a problem.

*2011, 2010-System functional-Deck needs over haul and a drinking system in planned to be installed.*

***Over the Hill: Decommission***

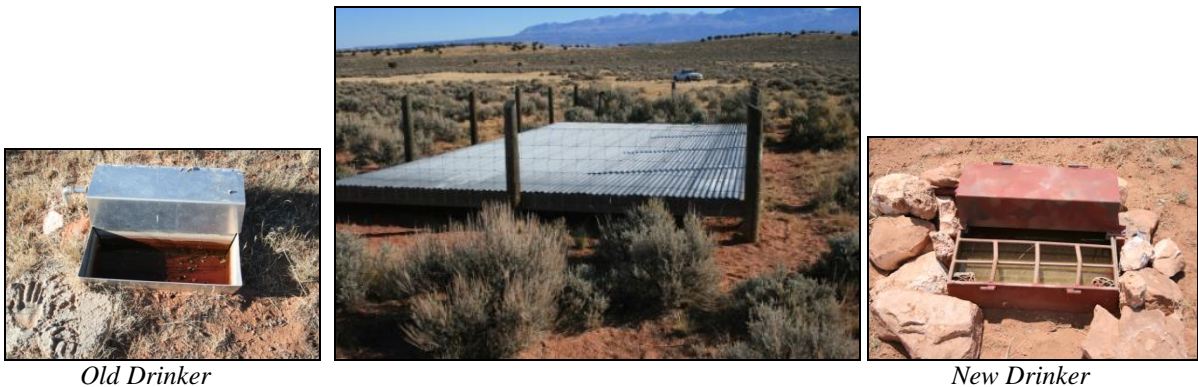
**Over the Hill II**  
**UTM NAD 27 Zone 12 626621/4241110**  
**No BLM Rights-of Way**

**2012** – System was turned on in the spring and turned back off in the fall when the cows returned to the range. Sediment tank pumped out, cleaned and inspected. Storage tank has water and system is in good shape.

*2011- Storage tank has water. Drinker replaced.. 2010- Storage tank has water. Brush cleared from around system.*

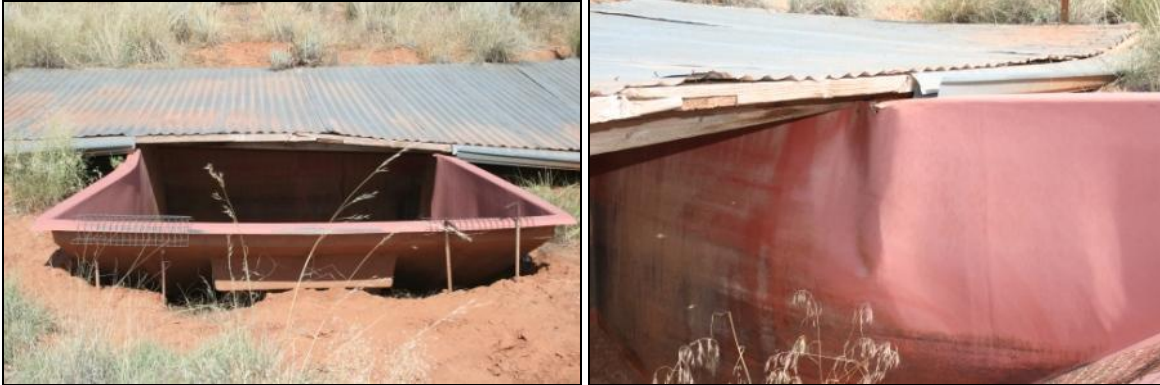
**Lost Guzzler – Another Over the Hill (III)**  
**2012 – Not inspected**

**2011** - In the fall of 2010, Guy Wallace, DWR Biologist in the Monticello area mentioned there was another guzzler that had been installed many years ago that he had forgotten about and had not been to in quite some time. Unfortunately, the storage reservoir does not hold water anymore and the catchment surface is in very poor condition, therefore restoration is not an option. The system will be removed and if appropriate and funding is available, a new system may be installed.

***Lost-Over the Hill III-Off line, not repairable-Remove/Replace***
